Fantasy Marble, LLC

Model Designation: Panel System with Metal Studs

OFFICIAL TEST REPORT

SPECIFICATIONS: Florida Building Code TAS 201, TAS 202 AND TAS 203 PROJECT: Miami Dade County

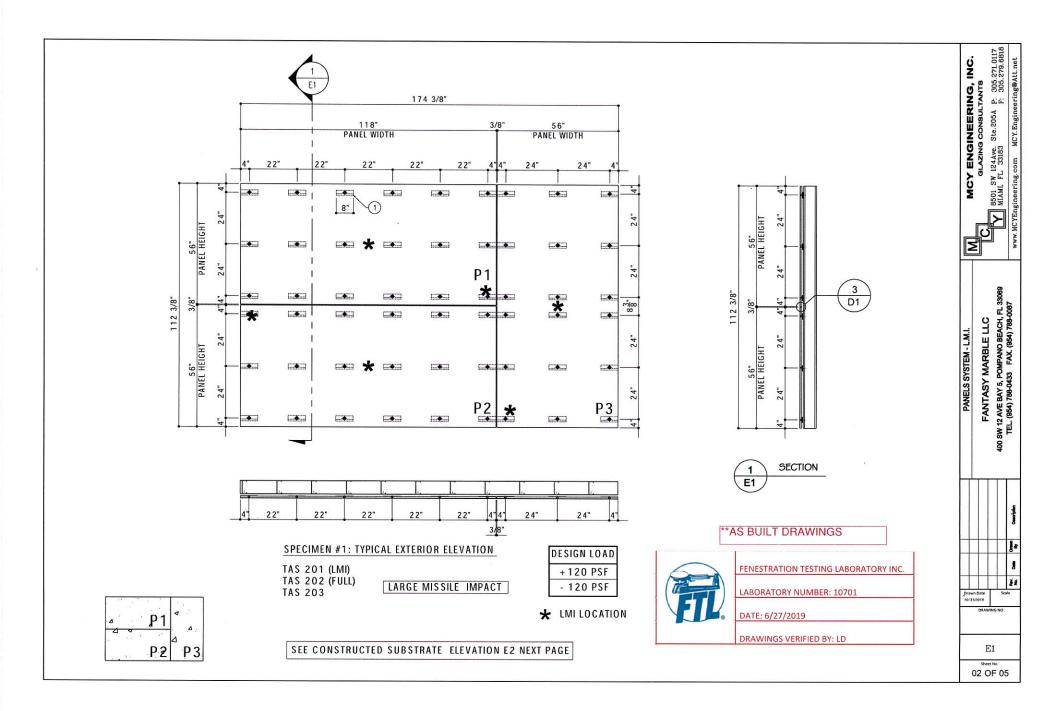
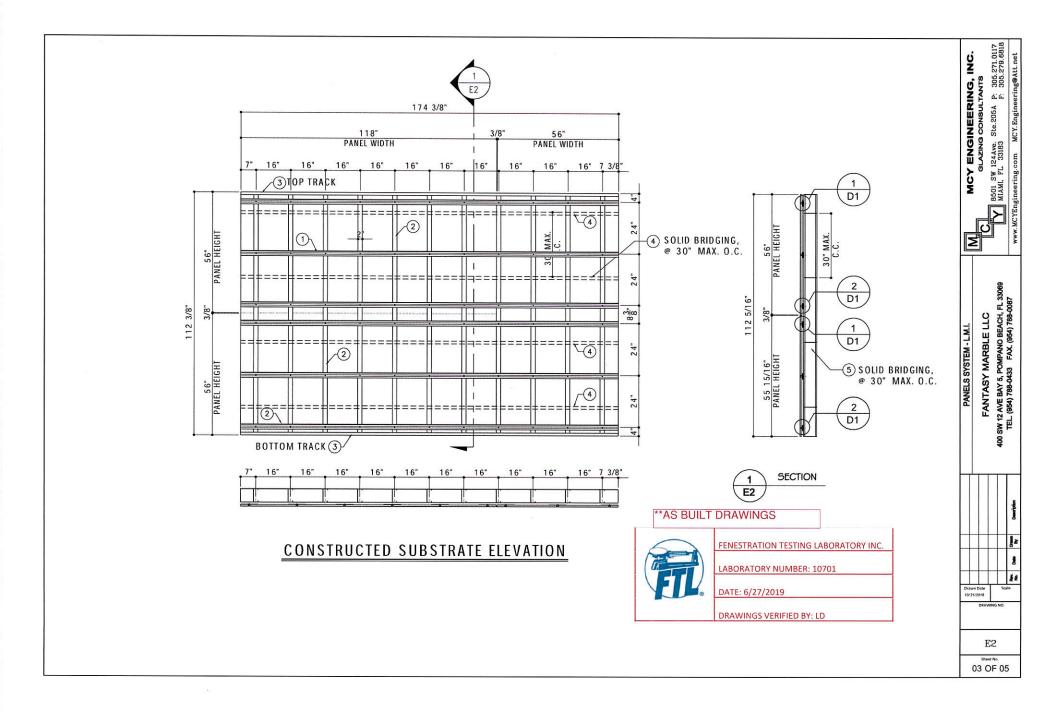
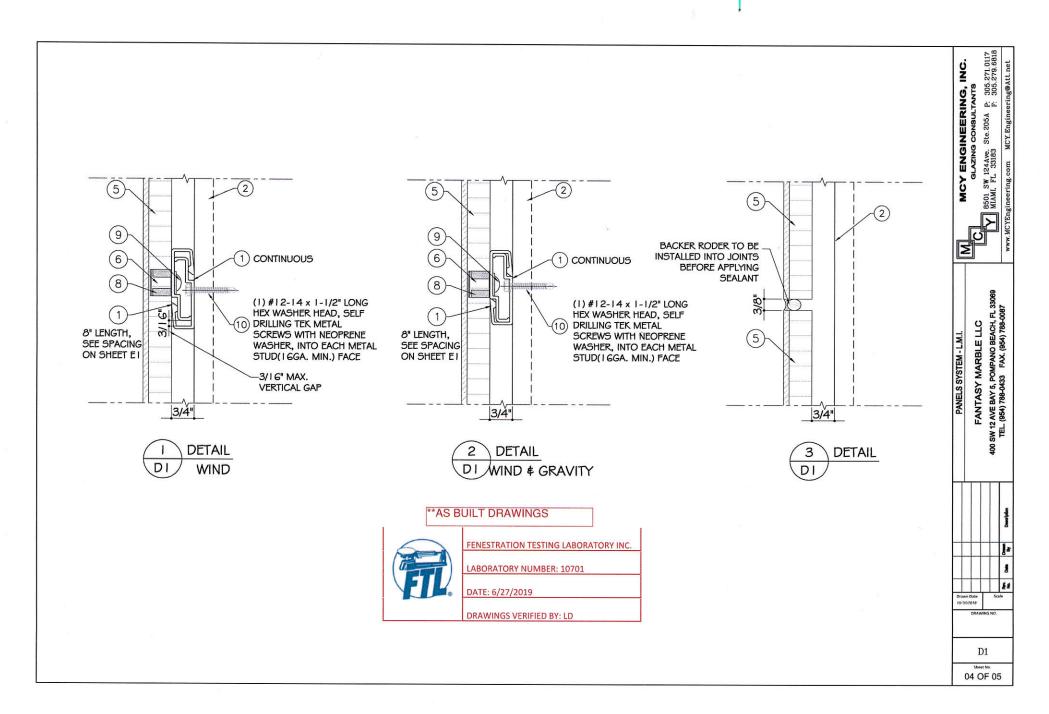
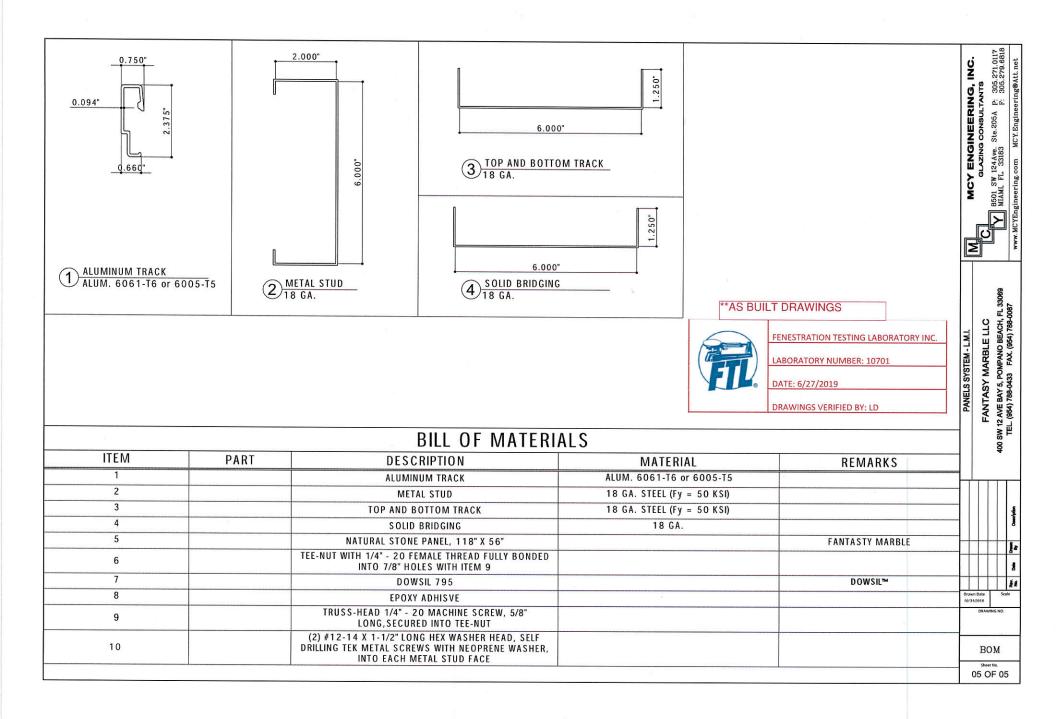
TESTING DRAWINGS PANEL SYSTEM W/ METAL STUDS

This sample was installed onto an 18-gauge metal stud wall using an extruded aluminum track, item 1. The tracks are full length and located from bottom at 4", 28", 52", 60 3/8" and 108 3/8". The tracks are fastened to each stud using one NO. 12 by 1 ½" HWH SDS with neoprene washer. The panels have one 8" long extruded aluminum track (item 1) located from left 4", 26", 48", 70", 92", 114", 122 3/8", 146 3/8" and 170 3/8", from bottom 4", 28", 52", 60 3/8", 84 3/8", and 108 3/8". The tracks are fastened to the panels using one **Tee-Nut with ¼"-20 female thread fully bonded into a 7/8" hole using epoxy adhesive and one ¼-20 by 5/8" TH MS.
